Towards a simpler and safer nuclear sector: The 2005 THORP Internal Leak

By Prof Francis Livens, Dr William Bodel

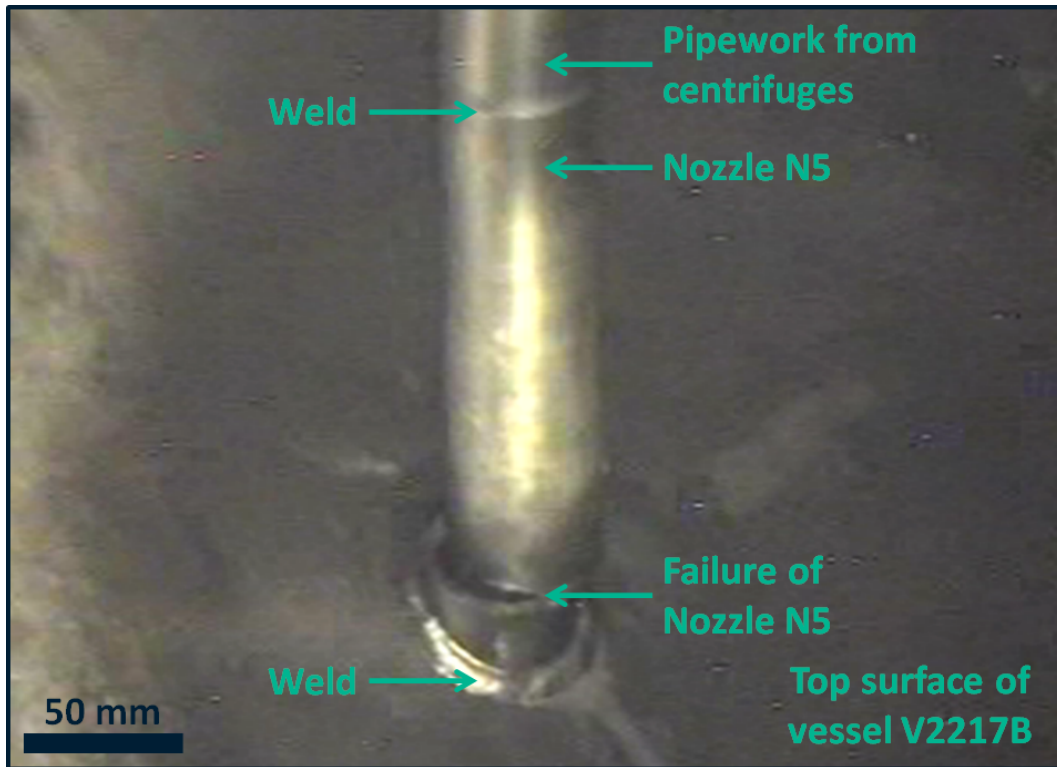
Part of the feed clarification cell, Vessel V2207B, is a 23 m³ Head End accountancy tank, where centrifuged liquor is weighed. Nozzle N5 (**Figure 2**) connected the centrifuges to Vessel V2207B and it was the failure of this nozzle that led to the leak of radioactive liquor.

Mechanically, the cause of the shearing of Nozzle N5 from its vessel was attributed to fatigue failure from repeated and continued oscillation of the accountability tank, which is suspended to allow for weighing of the vessel.

Normal operation of the accountability tank involves blending the dissolver liquor within it using a pulse jet and, as a consequence, the agitated contents initiate motion of the tank. This movement was accommodated in the original design of the cell with a restraining mechanism, but a modification to the operation of the vessel in 1997 removed the restraint, enabling the failure.

Figure 2: Image showing the severance of Nozzle N5 from the accountancy tank into which the dissolver liquor should have fed. (Source: adapted from [4])

The cause of the leak was modification to the accounting vessel which did not consider the detrimental impact this would have on the connecting pipework, ultimately causing a guillotine failure on Nozzle N5. Full assessment of the impact of any design changes should have been carried out, with consideration paid to understanding the original design before any modifications were carried out. The importance of second-order thinking eloquently described by G.K. Chesterton with his heuristic fence² applies as much in engineering as it does to policy decisions.
